Reconnaissance Report
Shore Protection And Erosion Control Project

Siasconset Shore Protection Study Nantucket, Massachusetts

**US Army Corps
of Engineers**
New England Division

June 1994

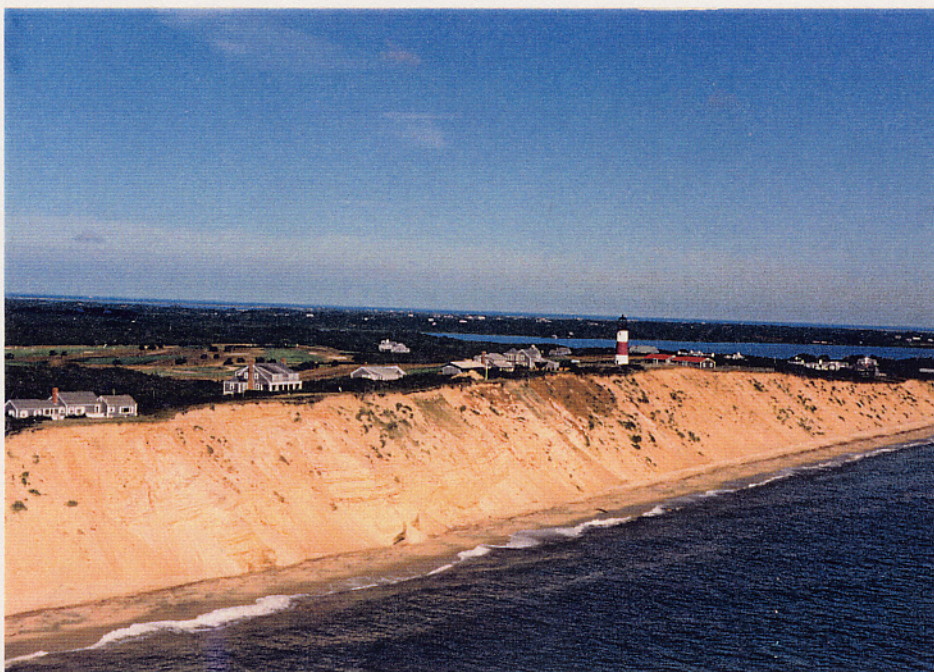
SIASCONSET, NANTUCKET, MA
Bluff-vicinity Sankaty Light Station -
Looking Northwest
August 1988

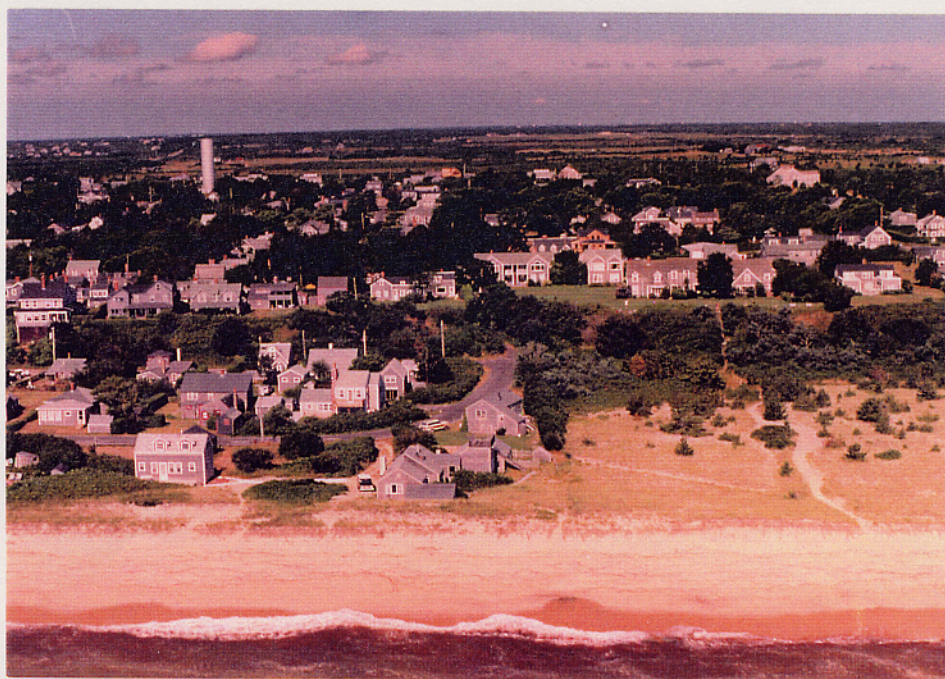
SIASCONSET, NANTUCKET, MA
Codfish Park and North - Looking West
(Note: Developed and undeveloped berm
and developed backshore bluff)
August 1988

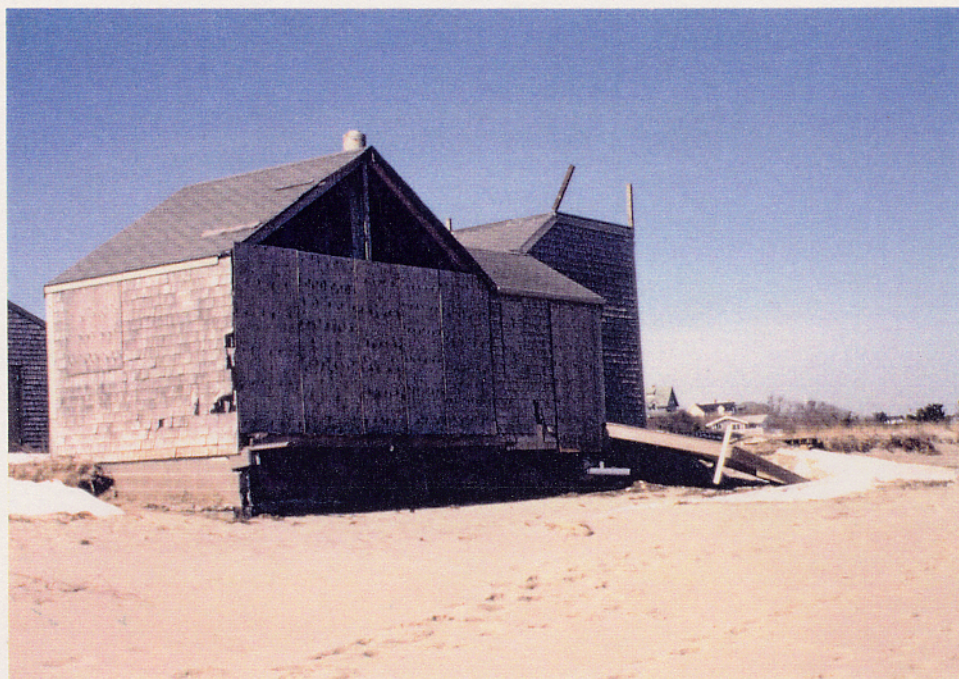
SIASCONSET, NANTUCKET, MA
 Codfish Park - House Abandoned to Erosion
 February 1994

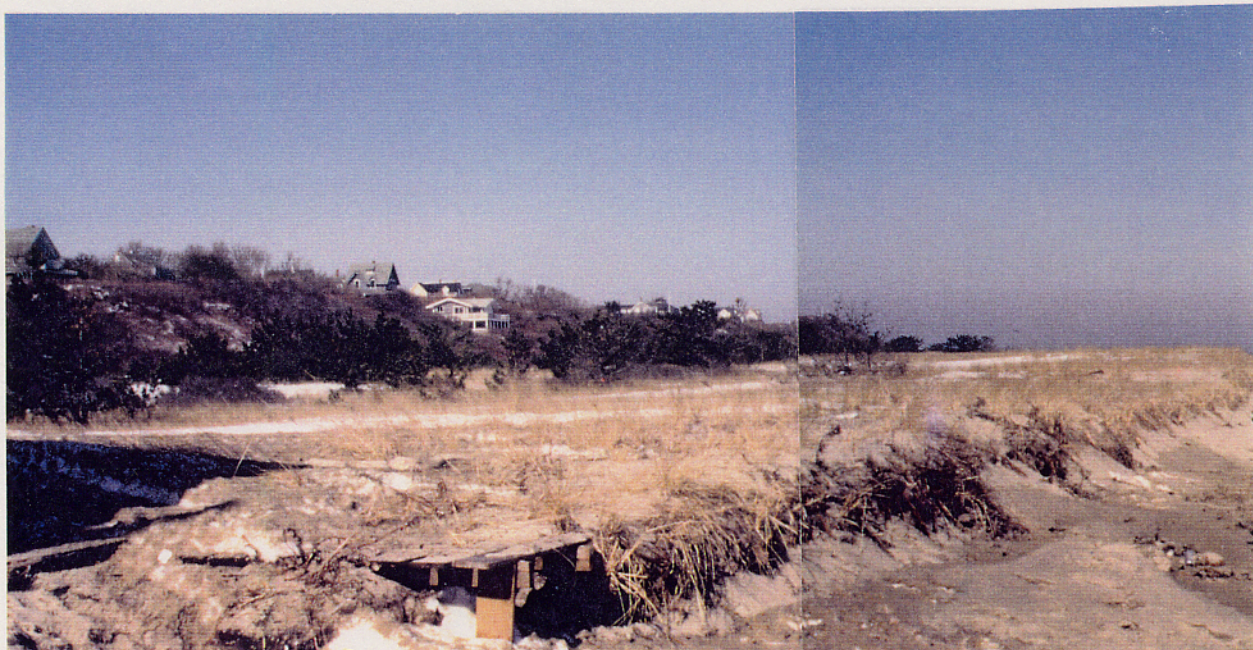
SIASCONSET, NANTUCKET, MA
 North of Codfish Park - Looking North
 (Note: Undeveloped berm and developed
 backshore bluff)
 February 1994
